**Flood Control Project Maintenance
Levee Inspections**
LMA District Cover Sheet
Spring 2020 Levee Inspection Results

Tehama County Flood Control and Water Conservation District

Waterway	Bank	Unit Miles
Unit No. 01 Deer Creek	Left	4.22

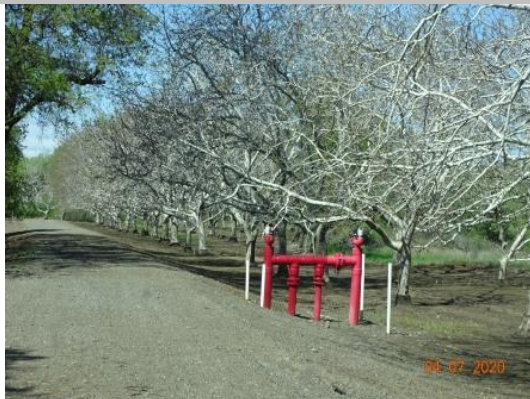
Photo 1 of 1 : SP_2020_NA0019_78_275_20200413_00067.jpg

LM Start	0.02	Rating **	U	Issue No.	275
LM End	0.02	Issue Type +	En	Location *	WS
Category	Earthen Levee			GPS Latitude/Longitude	
				Start	End
Item	Encroachments			39.973128 °	39.973128 °
				-121.980734 °	-121.980734 °
DWR ID	DWR_NA0019_01_s_2014_275				
Comment Code					
PI : Pipe					
Inspector Comment

View of the irrigation pipe along the waterside slope. Spring 2020.

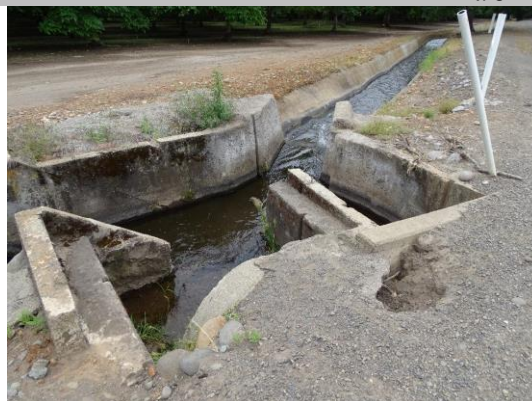
Photo 2 of 3 : UCIP_SP_2020_53998_79243.jpg

Comment Code						
Inspector Comment						
DS_ID:24684 FS_ID:53998 EP_NO: N/A Repair Type: Non-Urgent Crossing Status: Found UCIP Comments: 5/14/2019 Record remains Non-Urgent. No permit for this crossing was found. Pipe is designed to drain excess of water from irradiation canal to Deer Creek. Backflow prevention device is missing on this crossing. (O.Yakimov - DWR UCIP) 10/02/2013 No permit identified for this crossing. (W.Wylie - DWR UCIP) FIELD_STRUCT_DESC: 36-inch reinforced concrete drainage pipe through the levee, 0.5 feet below the crown. Concrete canal and distribution structure on the landside (LS) shoulder. FS Date: 5/14/2019 2:33:44 PM

Irrigation canal at LS shoulder

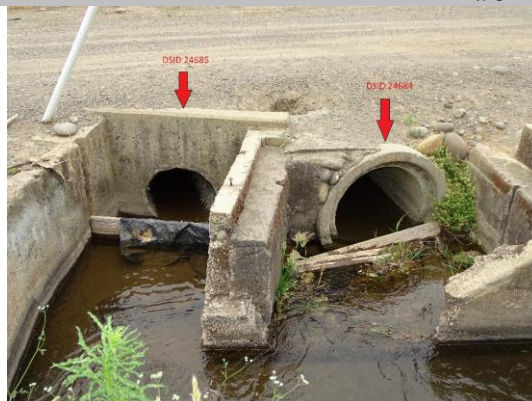
Photo 1 of 3 : UCIP_SP_2020_53999_79247.jpg

LM Start	0.17	Rating **	M	Issue No.	277
LM End	0.17	Issue Type +	En	Location *	
Category	Supplemental			GPS Latitude/Longitude	
				Start	End
Item	DWR UCIP Field Study			39.973285 °	39.973285 °
				-121.983531 °	-121.983531 °
DWR ID	24685				
Comment Code					
Inspector Comment					
DS_ID:24685 FS_ID:53999 EP_NO: N/A Repair Type: Non-Urgent Crossing Status: Found UCIP Comments: 05/14/2019 Pipe is designed to drain excess of water from irrigation canal to Deer Creek. (O.Yakimov - DWR UCIP)No permit identified for this crossing. FIELD_STRUCT_DESC: 24-inch reinforced concrete irrigation pipe through the levee, 2 feet below the crown. Concrete canal and distribution structure on the landside (LS) shoulder. Concrete U-shaped headwall and flap gate on the waterside (WS) toe. FS Date: 5/14/2019 3:06:17 PM

Concrete headwall at irrigation canal on LS shoulder

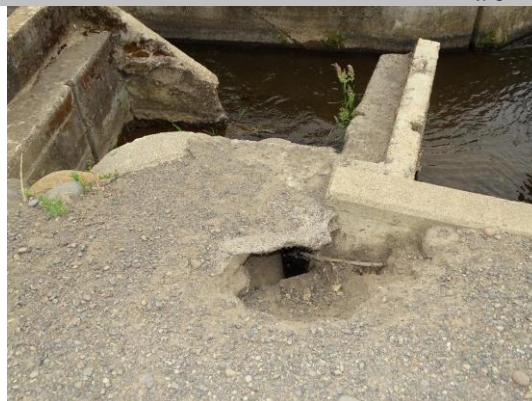
Photo 3 of 3 : UCIP_SP_2020_53999_79249.jpg

Erosion at concrete headwall

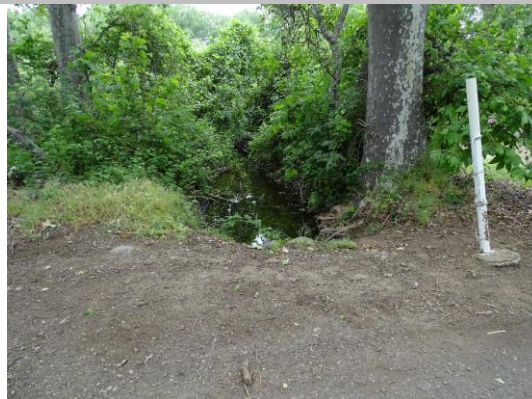
Photo 2 of 3 : UCIP_SP_2020_54000_79254.jpg

LM Start	0.49	Rating **	M	Issue No.	280
LM End	0.49	Issue Type +	En	Location *	
Category	Supplemental			GPS Latitude/Longitude	
				Start	End
Item	DWR UCIP Field Study			39.972280 °	39.972280 °
				-121.989227 °	-121.989227 °
DWR ID	24686				
Comment Code					
Inspector Comment					
DS_ID:24686 FS_ID:54000 EP_NO: N/A Repair Type: Non-Urgent Crossing Status: Found UCIP Comments: 05/14/2019 Pipe is designed to drain excess of water from irrigation canal to Deer Creek. Backflow prevention device is absent on this crossing. (O.Yakimov - DWR UCIP)No permit identified for crossing. FIELD_STRUCT_DESC: 20-inch reinforced concrete irrigation pipe through the levee, 2 feet below the crown. Concrete canal and distribution structure with slat boards on the landside (LS) shoulder. FS Date: 5/14/2019 3:11:32 PM

View of pipe on WS toe

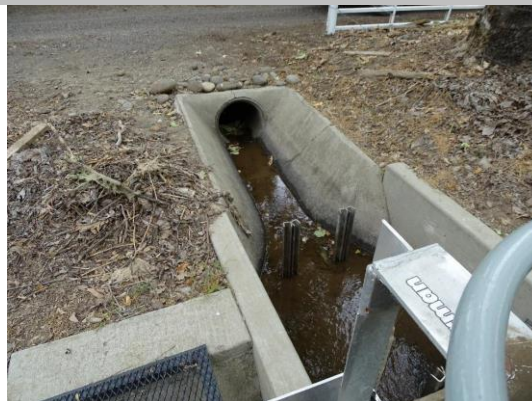
Photo 3 of 3 : UCIP_SP_2020_54000_79259.jpg

View of headwall from irrigation canal

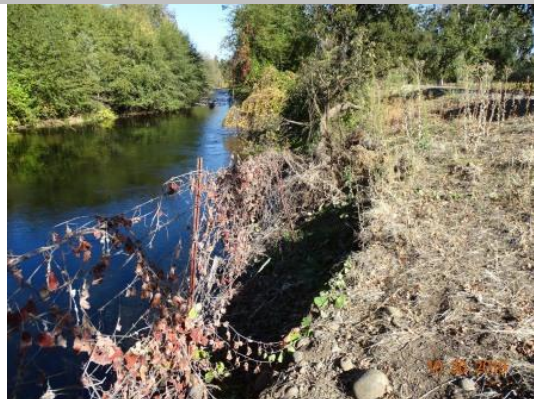
Photo 1 of 1 : SP_2020_NA0019_78_49_20200416_00072.jpg

LM Start	1.55	Rating **	A/W	Issue No.	49
LM End	1.58	Issue Type +	Ma	Location *	WS
Category	Supplemental			GPS Latitude/Longitude	
				Start	End
Item	2017 Storm Damage			39.969193 °	39.969052 °
				-122.008458 °	-122.008920 °
DWR ID	LMA-500				
Comment Code					
Inspector Comment					
Planned For Repair. Significant erosion on the waterside slope, 8-10 foot vertical bank for approximately 100-150 feet Site ID No:585 Site Designation:LMA-500 Rating:Critical Field Date:9/6/2017

View of erosion along waterside toe. Fall 2019.

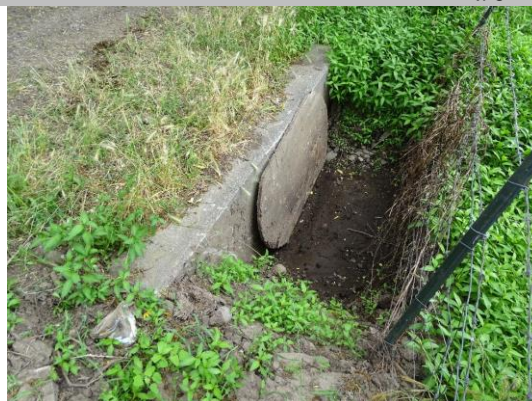
Photo 1 of 3 : UCIP_SP_2020_54006_79261.jpg

DS_ID:20770
FS_ID:54006
EP_NO: N/A
Repair Type: Non-Urgent
Crossing Status: Found
UCIP Comments: 05/14/2019 Pipe end on WS has been cleared from sediment buildup to let flap gate close properly, but the rest of pipe is still silted inside. Flap gate was fixed and operable now. (O.Yakimov - DWR UCIP)10/15/2018 Flap gate on WS end stuck open. Lower part of pipe is silted that makes impossible flap gate to fully close. Needs sediment cleanup around pipe outlet on WS. (O.Yakimov - DWR)12/05/2016 Sediment buildup inside pipe (see photo) and sediment buildup on WS blocking flap gate. Crossing has been downgraded from Urgent to Non-Urgent crossing was closed on both WS and LS. (O. Magana - DWR UCIP)10/02/2013 Flapgate blocked by soil buildup. (W. Wylie - DWR UCIP)
FIELD_STRUCT_DESC: 24-inch steel drainage pipe through the levee, 1.5 feet below the crown. Flap gate on the waterside (WS) toe.
[Additional Reference(s): DWR Levee Log, 1992. USACE Sacramento O&M Manual Unit 509, March 1957, As-built drawings available 50-4-2394 (Station 185+40)].

LS view of concrete headwall with wood panel blocking opening

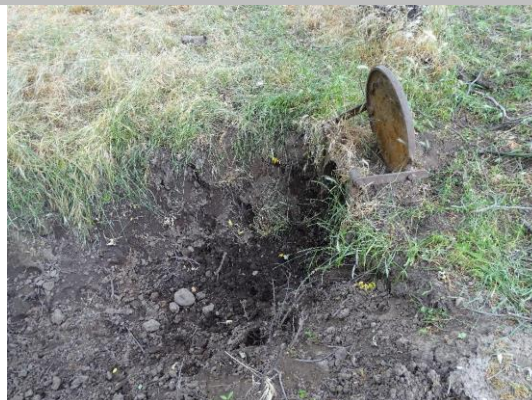
Photo 2 of 3 : UCIP_SP_2020_54006_79262.jpg

Flap gate at WS toe

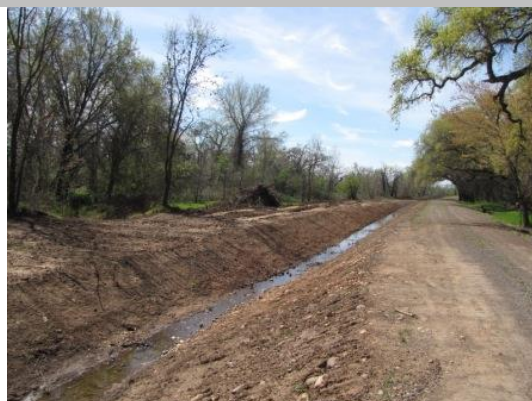
Photo 2 of 2 : SP_2020_NA0019_78_2_20200226_00002.jpg

View of an agricultural ditch along the levee toe.

LM Start	1.79	Rating **	U	Issue No.	2
LM End	2.22	Issue Type +	En	Location *	LS
Category	Earthen Levee			GPS Latitude/Longitude	
				Start	End
Item	Encroachments			39.969443 °	39.966921 °
				-122.012261 °	-122.019469 °
DWR ID	DWR_NA0019_01_s_2012_2				
Comment Code					
DT : Ditch					
Inspector Comment					
Repair the cleaned out irrigation ditch along the landside toe.

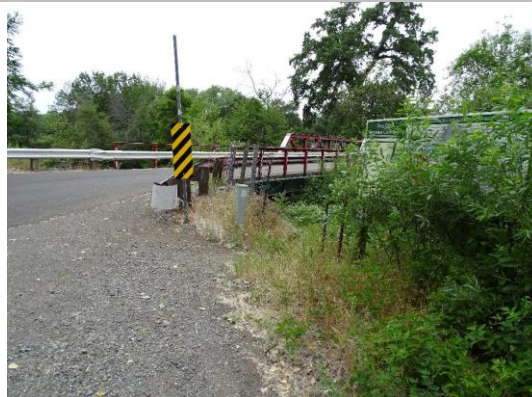
Photo 2 of 3 : UCIP_SP_2020_54007_79265.jpg

LM Start	1.88	Rating **	M	Issue No.	285	
LM End	1.88	Issue Type +	En	Location *		
Category	Supplemental			GPS Latitude/Longitude		
				Start	End	
Item	DWR UCIP Field Study			39.969156 °	39.969156 °	
				-122.013809 °	-122.013809 °	
DWR ID	24690					
Comment Code						
Inspector Comment						
DS_ID:24690 FS_ID:54007 EP_NO: N/A Repair Type: Non-Urgent Crossing Status: Found UCIP Comments: 05/14/2019 No changes to the crossing. (O.Yakimov - DWR UCIP)No permit identified for this crossing. FIELD_STRUCT_DESC: 4-inch steel communications conduit through the levee, at an unknown depth. Junction box off the landside (LS) toe next to JP and roadway. Conduit visible on upstream side of bridge at Deer Creek crossing. FS Date: 5/14/2019 3:54:01 PM

Leninger Rd bridge looking north. Communication box on road shoulder

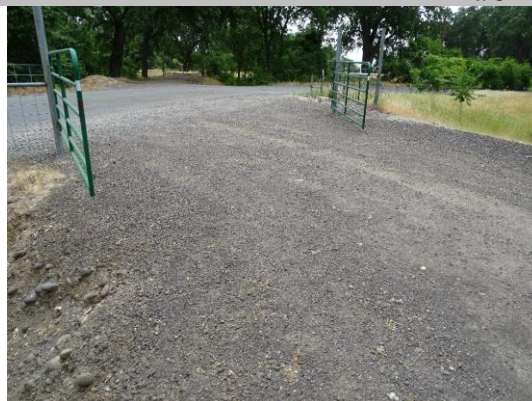
Photo 1 of 3 : UCIP_SP_2020_54008_79270.jpg

DS_ID:20769
FS_ID:54008
EP_NO: N/A
Repair Type: Urgent
Crossing Status: Found
UCIP Comments: 05/14/20198 Same as last inspection. Flapgate on WS is missing, pipe partially blocked with sedimen. (O.Yakimov - DWR UCIP)10/15/2018 Flapgate on WS is missing, pipe partially blocked with sediment. (O.Yakimov - DWR)12/05/2016 same as last inspection. Crossing remains "Urgent" WS opened during flood season due to damaged flap gate. (O. Magana - DWR UCIP)10/02/2013 Flapgate missing or burried on WS toe. Pipe partially blocked by soil on WS toe. (W. Wylie - DWR UCIP)
FIELD_STRUCT_DESC: 24-inch corrugated metal drainage pipe through the levee, 7 feet below the crown. Flap gate located on the waterside (WS) end. A 5-foot by 5-foot concrete control structure located on the landside (LS) toe. [Additional Reference(s): DWR Levee Log, 1992. USACE Sacramento O&M Manual Unit 509, March 1957, As-built drawing no. 50-4-2394 (Station 176+10)].

Overview of levee crown where pipe crosses

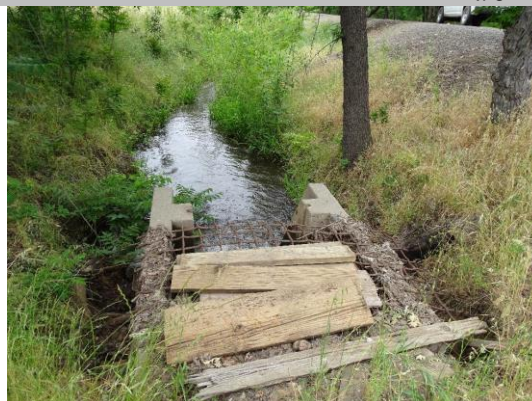
Photo 3 of 3 : UCIP_SP_2020_54008_79268.jpg

Concrete outfall structure at LS toe and irrigation canal

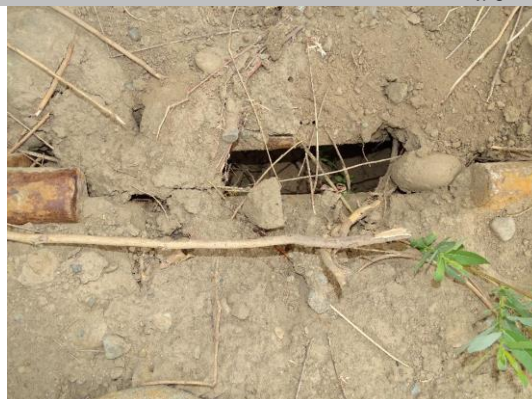
Photo 3 of 3 : UCIP_SP_2020_54011_79274.jpg

Pipe outlet discovered at WS toe. Visible gap between flap gate and pipe

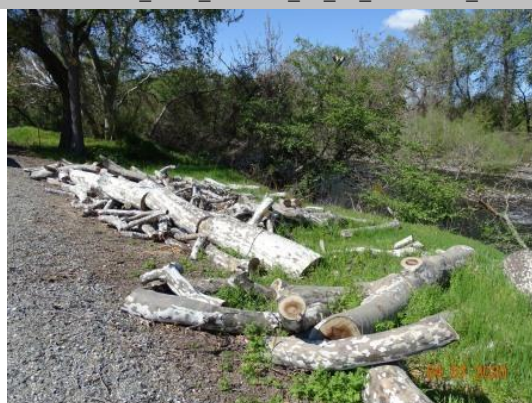
Photo 1 of 1 : SP_2020_NA0019_78_52_20200416_00074.jpg

LM Start	2.79	Rating **	M	Issue No.	52
LM End	2.79	Issue Type +	Ma	Location *	WS
Category	Earthen Levee			GPS Latitude/Longitude	
				Start	End
Item	Encroachments			39.964619 °	39.964619 °
				-122.029234 °	-122.029234 °
DWR ID	DWR_NA0019_01_s_2020_52				
Comment Code					
TR : Tree or limb					
Inspector Comment

View of tree limbs along the waterside toe. Spring 2020.

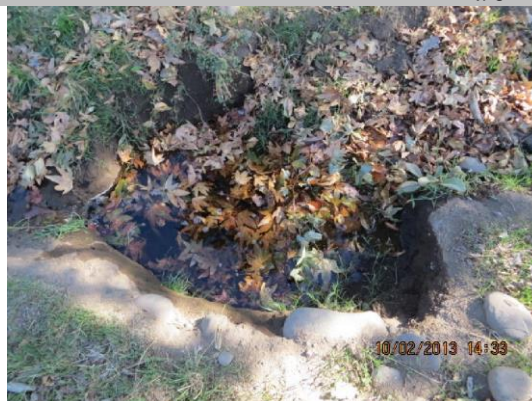
Photo 2 of 3 : UCIP_SP_2020_54013_38951.jpg

Low spot with water on LS toe.

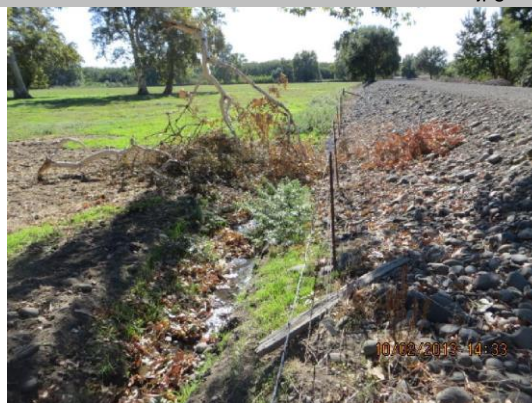
Photo 3 of 3 : UCIP_SP_2020_54013_38953.jpg

Low spot on LS toe where water disappears from levee toe. Unable to identify exact location of pipe on LS toe.

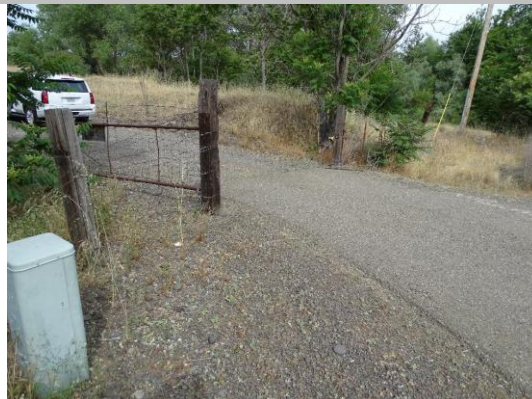
Photo 1 of 3 : UCIP_SP_2020_54014_79281.jpg

View of levee crown at the crossing. Communication box on LS shoulder

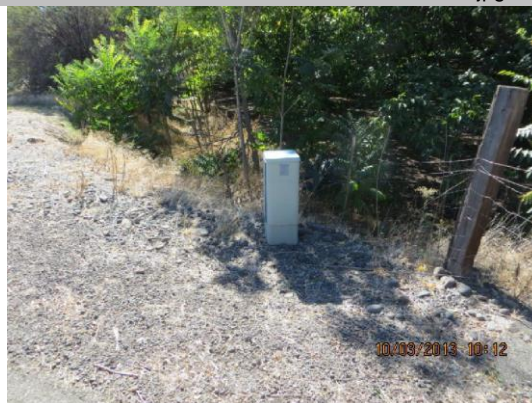
Photo 2 of 3 : UCIP_SP_2020_54014_39143.jpg

Communication cable junction box on LS shoulder.

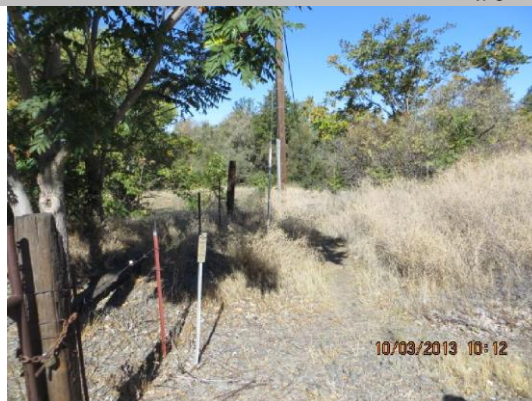
Photo 3 of 3 : UCIP_SP_2020_54014_39142.jpg

Communication cable visible at joint pole on WS slope

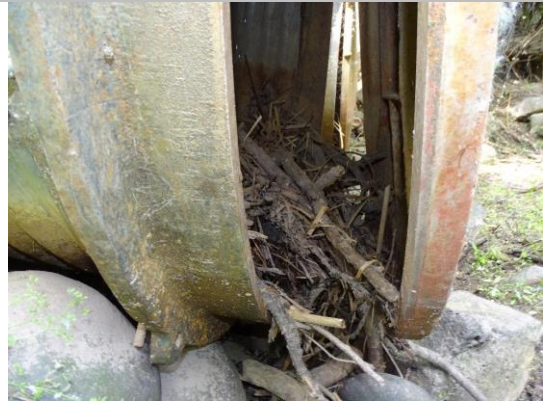
Photo 2 of 3 : UCIP_SP_2020_54016_79283.jpg

Debris inside the pipe

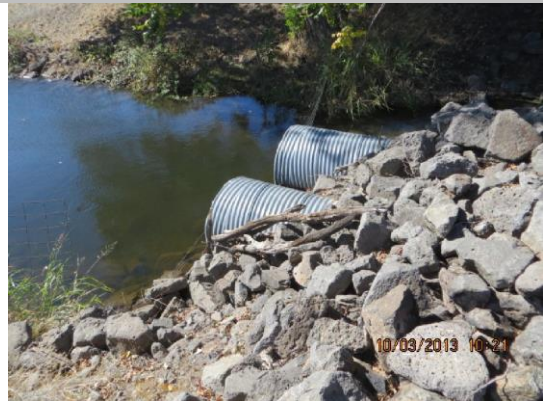
Photo 3 of 3 : UCIP_SP_2020_54016_39070.jpg

Pipe visible on LS toe

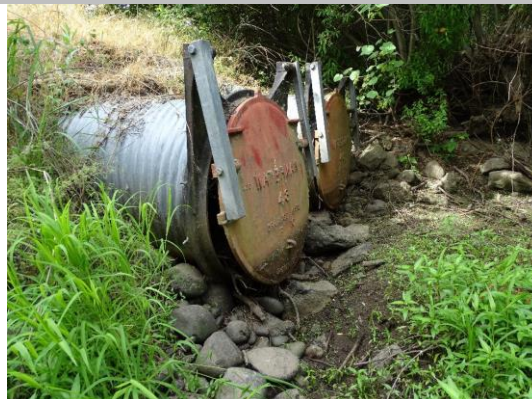
Photo 1 of 3 : UCIP_SP_2020_54017_79284.jpg

Flap gate on WS

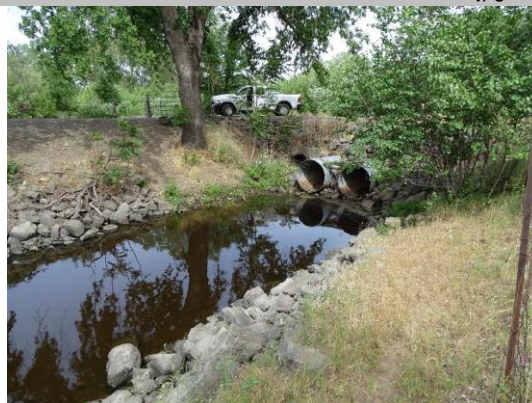
Photo 2 of 3 : UCIP_SP_2020_54017_79285.jpg

View of pipe inlet at LS toe

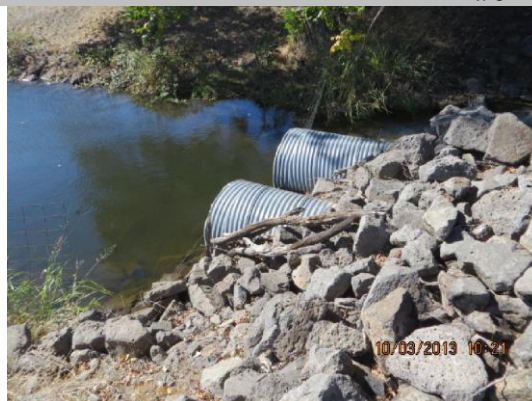
Photo 3 of 3 : UCIP_SP_2020_54017_39073.jpg

Pipe visible on LS toe

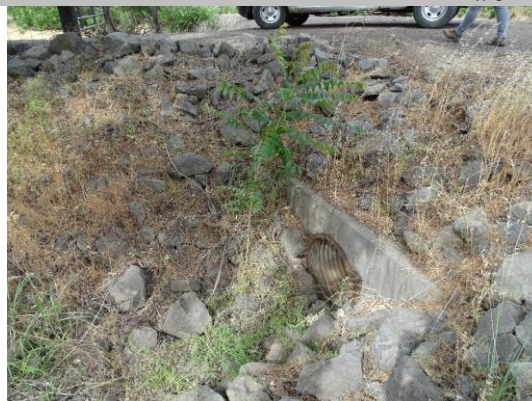
Photo 1 of 3 : UCIP_SP_2020_54018_79286.jpg

View of pipe inlet at LS toe

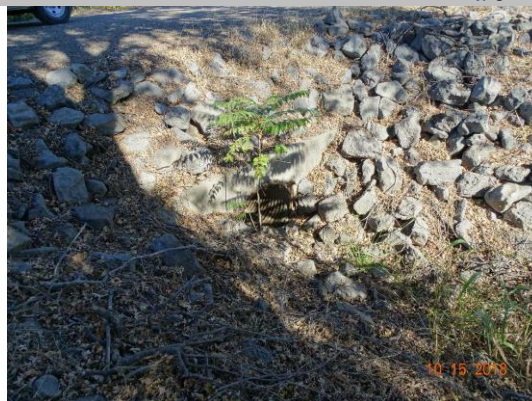
Photo 2 of 3 : UCIP_SP_2020_54018_78195.jpg

Pipe inlet at LS toe

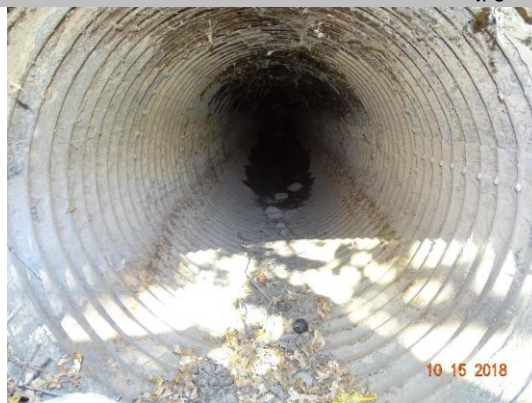
Photo 3 of 3 : UCIP_SP_2020_54018_78196.jpg

Inside view of the pipe looking from LS

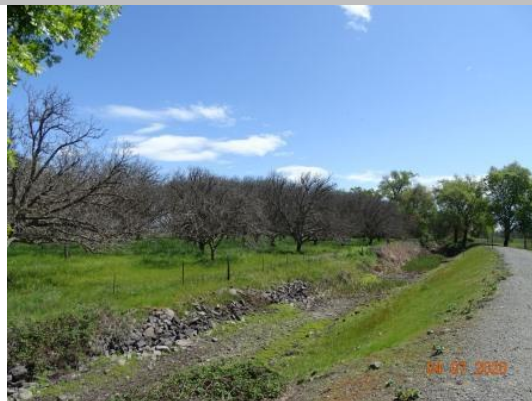
Photo 1 of 1 : SP_2020_NA0019_78_36_20200413_00070.jpg

LM Start	3.61	Rating **	U	Issue No.	36
LM End	3.69	Issue Type +	En	Location *	LS
Category	Earthen Levee			GPS Latitude/Longitude	
				Start	End
Item	Encroachments			39.945845 °	39.944878 °
				-122.054329 °	-122.053281 °
DWR ID	DWR_NA0019_01_f _ 2016_36				
Comment Code					
DT : Ditch					
Inspector Comment

View of the ditch along the landside slope. Spring 2020.

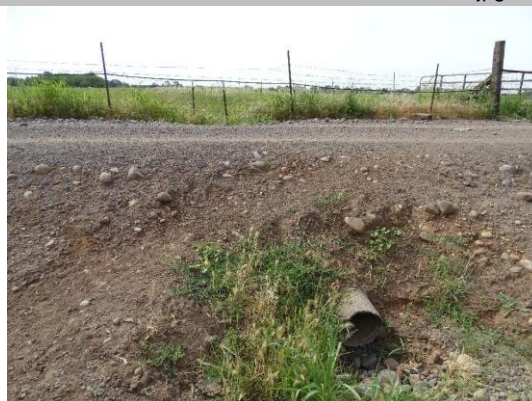
Photo 1 of 3 : UCIP_SP_2020_54021_79289.jpg

LM Start	3.75	Rating **	M	Issue No.	299
LM End	3.75	Issue Type +	En	Location *	
Category	Supplemental			GPS Latitude/Longitude	
				Start	End
Item	DWR UCIP Field Study			39.944460 °	39.944460 °
				-122.053930 °	-122.053930 °
DWR ID	20763				
Comment Code					
Inspector Comment					
DS_ID:20763 FS_ID:54021 EP_NO: N/A Repair Type: Non-Urgent Crossing Status: Found UCIP Comments: 05/14/2019 Backflow prevention device is not needed because LS elevation is higher then WS. (O.Yakimov - DWR UCIP) FIELD_STRUCT_DESC: 12-inch concrete drainage pipe, through the levee, 2-feet below the crown. FS Date: 5/14/2019 10:34:40 AM

View of pipe outlet at WS toe

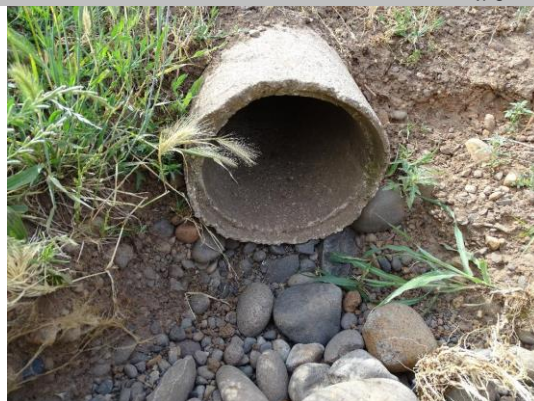
Photo 2 of 3 : UCIP_SP_2020_54021_79290.jpg

Concrete pipe outlet

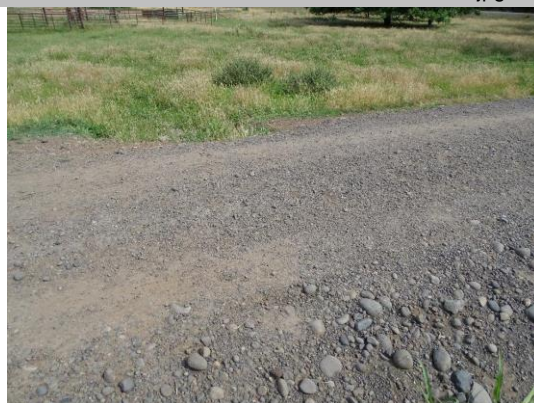
Photo 3 of 3 : UCIP_SP_2020_54021_79292.jpg

View of levee crown at the crossing

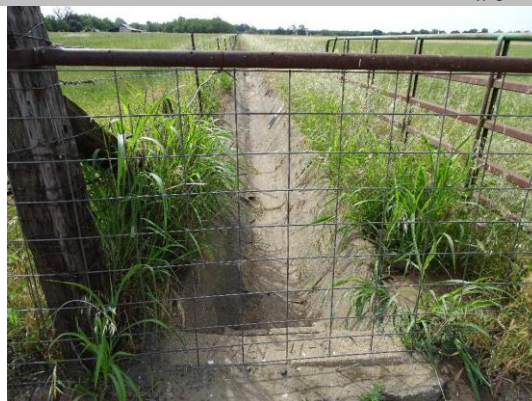
Photo 1 of 3 : UCIP_SP_2020_54022_79293.jpg

LM Start	3.75	Rating **	M	Issue No.	300	
LM End	3.75	Issue Type +	En	Location *		
Category	Supplemental			GPS Latitude/Longitude		
				Start		End
Item	DWR UCIP Field Study			39.944426 °	39.944426 °	
				-122.054045 °	-122.054045 °	
DWR ID	24691					
Comment Code						
Inspector Comment						
DS_ID:24691						
FS_ID:54022						
EP_NO: N/A						
Repair Type: Non-Urgent						
Crossing Status: Found						
UCIP Comments: 05/14/2019 Backflow prevention device is not needed because LS elevation is higher then WS. Pipe outlet partially blocked by sediment. (O.Yakimov - DWR UCIP)						
Outlet substantially blocked at WS toe. No permit identified for this crossing.						
FIELD_STRUCT_DESC: 10-inch reinforced concrete irrigation pipe through the levee, 2 feet below the crown. Slide gate at terminal end of concrete channel on the landside (LS) shoulder.						
FS Date: 5/14/2019 10:41:12 AM

Lined irrigation canal on LS

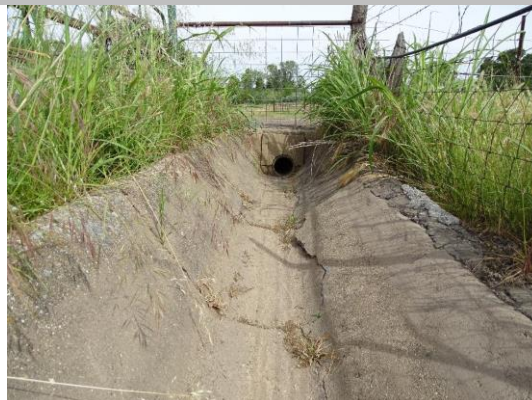
Photo 2 of 3 : UCIP_SP_2020_54022_79294.jpg

Lined irrigation canal and pipe inlet on LS

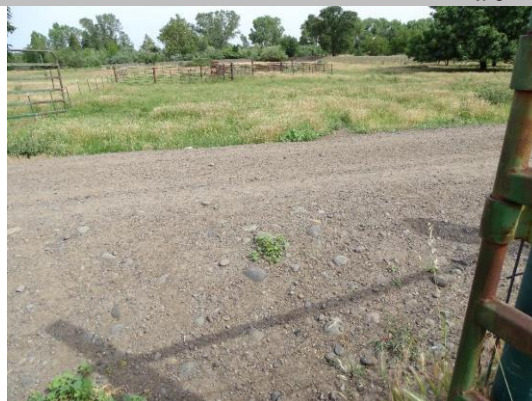
Photo 3 of 3 : UCIP_SP_2020_54022_79295.jpg

View of levee crown at the crossing

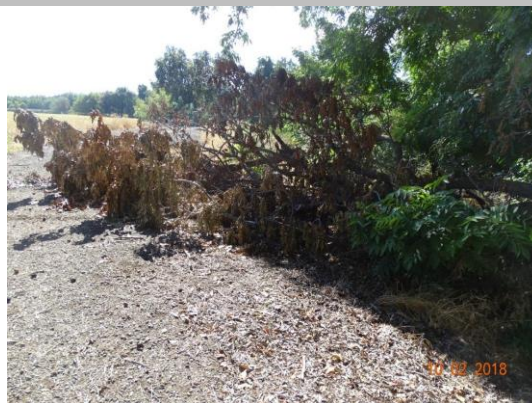
Photo 1 of 1 : SP_2020_NA0019_78_44_20200226_00014.jpg

LM Start	3.99	Rating **	M	Issue No.	44
LM End	3.99	Issue Type +	Ma	Location *	WS
Category	Earthen Levee			GPS Latitude/Longitude	
				Start	End
Item	Encroachments			39.941990 °	39.941990 °
				-122.057140 °	-122.057140 °
DWR ID	DWR_NA0019_01_f _ 2018_44				
Comment Code					
TR : Tree or limb					
Inspector Comment					
The tree should be removed from the waterside slope.

View of the tree limb along the waterside slope.

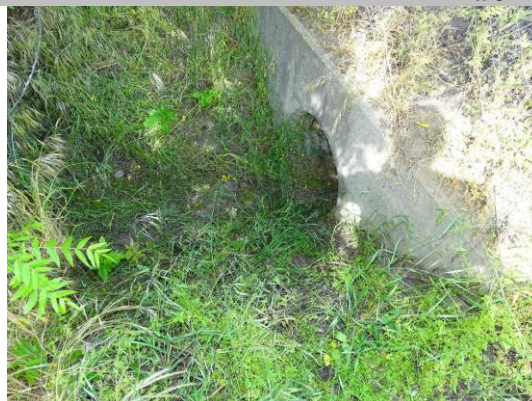
Photo 1 of 3 : UCIP_SP_2020_54023_79298.jpg

LM Start	4.03	Rating **	M	Issue No.	301
LM End	4.03	Issue Type +	Ma	Location *	
Category	Supplemental			GPS Latitude/Longitude	
				Start	End
Item	DWR UCIP LMA Responsibility			39.941574 °	39.941574 °
				-122.057597 °	-122.057597 °
DWR ID	20760				
Comment Code					
Inspector Comment					
DS_ID:20760 FS_ID:54023 EP_NO: N/A Repair Type: Non-Urgent Crossing Status: Found UCIP Comments: 05/14/2019 No issues recorded during inspection. (O.Yakimov - DWR UCIP) FIELD_STRUCT_DESC: 24-inch corrugated metal drainage pipe through the levee, 5 feet below the crown. Flap gate on the waterside (WS) end. Headwalls on both sides of levee. [Additional Reference(s): DWR Levee Log, 1992. USACE Sacramento O&M Manual 509, March 1957, (Assumed Station 5+00) Drawing No. 50-4-2394]. FS Date: 5/14/2019 10:53:58 AM

Headwall and pipe inlet at LS toe

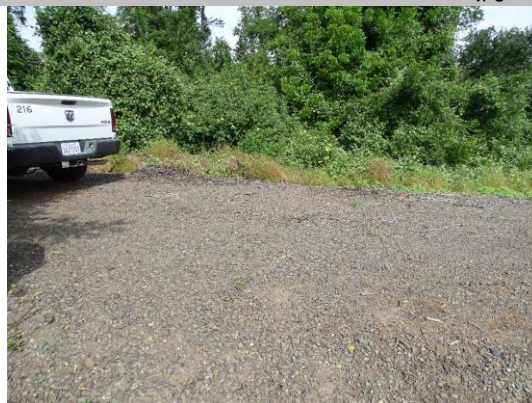
Photo 2 of 3 : UCIP_SP_2020_54023_79299.jpg

View of levee crown at the crossing

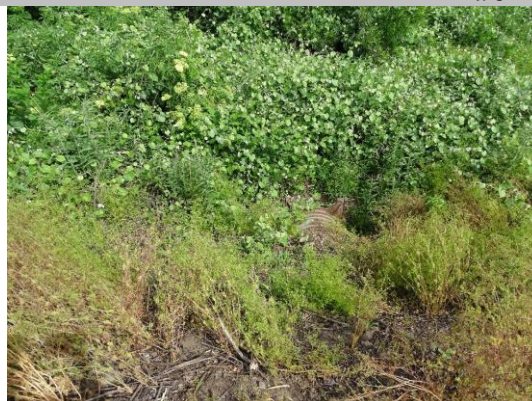
Photo 3 of 3 : UCIP_SP_2020_54023_79300.jpg

Pipe and flap gate at WS slope

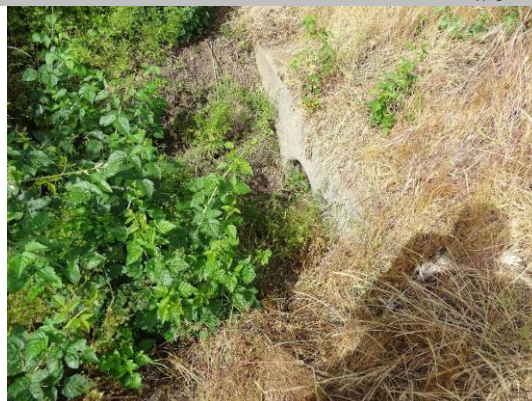
Photo 1 of 3 : UCIP_SP_2020_54024_79304.jpg

LM Start	4.11	Rating **	U	Issue No.	302
LM End	4.11	Issue Type +	Ma	Location *	
Category	Supplemental		GPS Latitude/Longitude		
			Start	End	
Item	DWR UCIP LMA Responsibility		39.940933 °	39.940933 °	
			-122.058894 °	-122.058894 °	
DWR ID	20762

DS_ID:20762
FS_ID:54024
EP_NO: N/A
Repair Type: Urgent
Crossing Status: Found
UCIP Comments: 05/14/2019 Missing flap gate, pipe outlet is silted. (O.Yakimov - DWR UCIP)10/15/2018 Missing flap gate at WS end of the pipe. Pipe is partially blocked with silt. Updated coordinates and CLM. (O.Yakimov - DWR)12/05/2016 unable to complete inspection -- unable to locate. (O. Magana - DWR UCIP)10/03/2013 Gate missing from WS toe. (W. Wylie - DWR UCIP)
FIELD_STRUCT_DESC: 24-inch corrugated metal drainage pipe through the levee, 5.5 feet below the crown. Flap gate located on the waterside (WS) end. Concrete headwall located on the landside (LS) toe. [Additional Reference(s): DWR Levee Log, 1992. USACE Sacramento O&M Manual Unit 509, March 1957, As-built drawing no. 50-4-2394 (Station 0+65)].
FS Date: 5/14/2019 11:01:16 AM

Headwall and inlet at LS toe

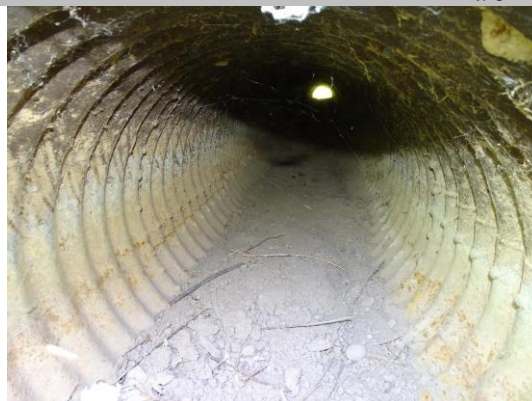
Photo 2 of 3 : UCIP_SP_2020_54024_79305.jpg

Inside view of pipe looking from LS

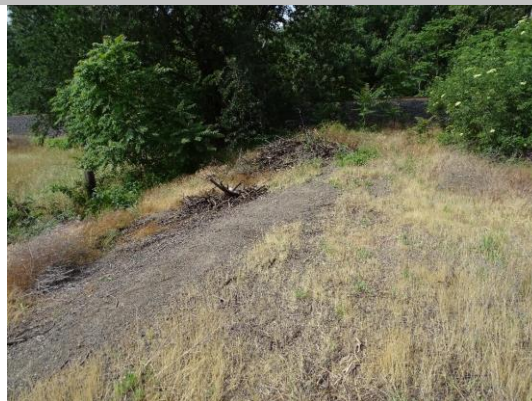
Photo 3 of 3 : UCIP_SP_2020_54024_79303.jpg

View of levee crown at the crossing

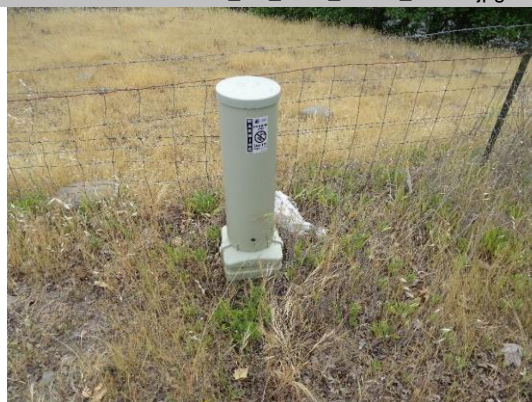
Photo 1 of 3 : UCIP_SP_2020_53996_79235.jpg

LM Start	0.31	Rating **	M	Issue No.	17	
LM End	0.31	Issue Type +	En	Location *		
Category	Supplemental			GPS Latitude/Longitude		
				Start		End
Item	DWR UCIP Field Study			39.970256 °		39.970256 °
				-122.014471 °		-122.014471 °
DWR ID	24683					
Comment Code						
Inspector Comment						
DS_ID:24683 FS_ID:53996 EP_NO: N/A Repair Type: Non-Urgent Crossing Status: Found UCIP Comments: 5/14/2019 Record remains Non-Urgent. No permit was found authorizing this crossing. (O.Yakimov - DWR UCIP) 10/02/2013 No permit identified for this crossing. (W.Wylie - DWR UCIP) FIELD_STRUCT_DESC: 4-inch galvanized iron communications conduit through the levee, at an unknown depth. Pipe visible on upstream side of bridge. FS Date: 5/14/2019 12:58:37 PM

Communication line access box on east side of Leninger Rd

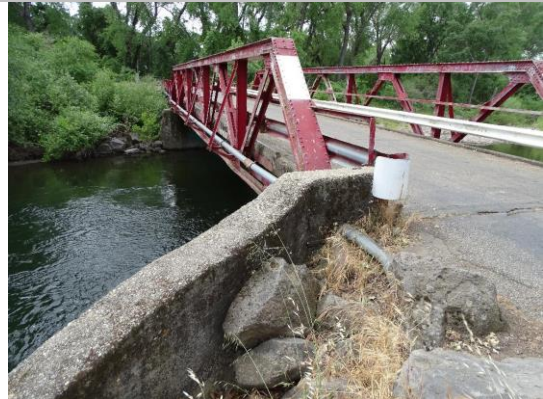
Photo 2 of 3 : UCIP_SP_2020_53996_79236.jpg

Conduit on upstream side on Leninger Rd bridge

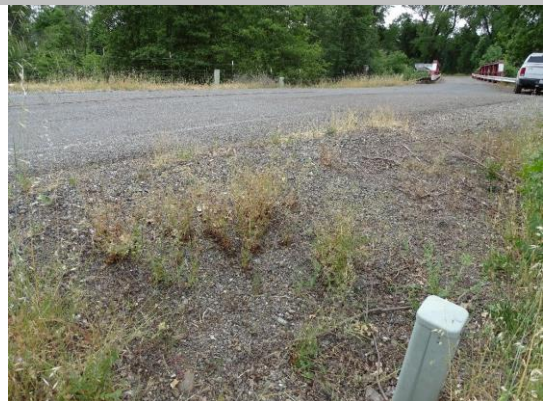
Photo 3 of 3 : UCIP_SP_2020_53996_79237.jpg

Two AT&T underground cable boxes located on east side of Leninger Rd

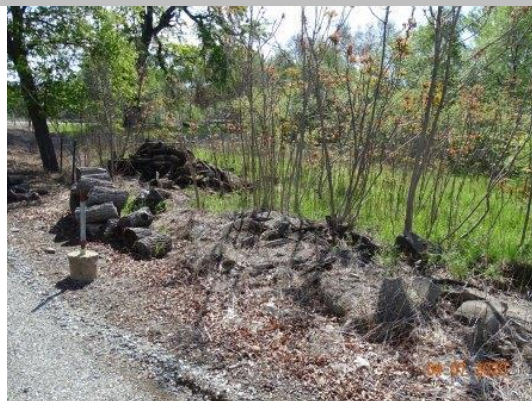
Photo 1 of 1 : SP_2020_NA0019_79_4_20200413_00013.jpg

LM Start	0.34	Rating **	M	Issue No.	4
LM End	0.34	Issue Type +	En	Location *	WS
Category	Earthen Levee			GPS Latitude/Longitude	
				Start	End
Item	Encroachments			39.970210 °	39.970210 °
				-122.015198 °	-122.015198 °
DWR ID	DWR_NA0019_02_s_2012_4				
Comment Code					
DE : Debris					
Inspector Comment

View of concrete and firewood piles along the waterside slope. Spring 2020.

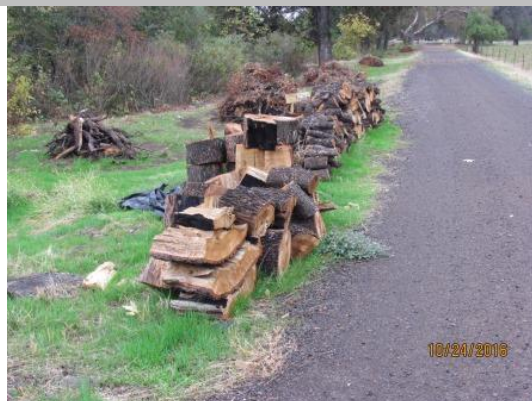
Photo 1 of 1 : SP_2020_NA0019_79_14_20200226_00006.jpg

LM Start	0.35	Rating **	M	Issue No.	14
LM End	0.35	Issue Type +	En	Location *	WS
Category	Earthen Levee			GPS Latitude/Longitude	
				Start	End
Item	Encroachments			39.970153 °	39.970153 °
				-122.015194 °	-122.015194 °
DWR ID	DWR_NA0019_02_f_2016_14				
Comment Code					
FW : Firewood					
Inspector Comment

View of the firewood along the waterside slope.

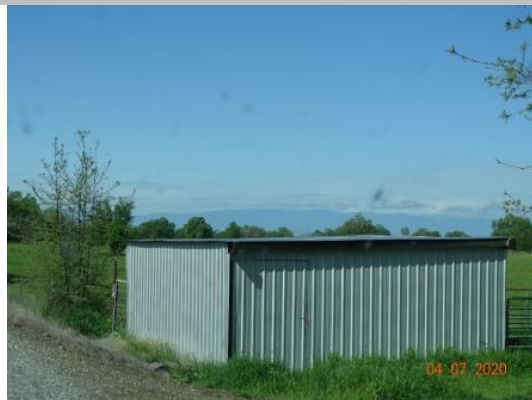
Photo 1 of 1 : SP_2020_NA0019_79_7_20200413_00014.jpg

LM Start	0.35	Rating **	M	Issue No.	7
LM End	0.35	Issue Type +	En	Location *	LS
Category	Earthen Levee			GPS Latitude/Longitude	
				Start	End
Item	Encroachments			39.970117 °	39.970117 °
				-122.015365 °	-122.015365 °
DWR ID	DWR_NA0019_02_s_2012_7				
Comment Code					
BU : Building					
Inspector Comment

View of a building at the landside toe. Spring 2020.

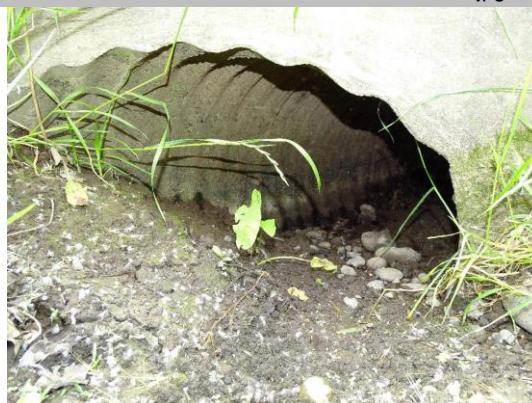
Photo 1 of 3 : UCIP_SP_2020_53997_79240.jpg

Comment Code					
Inspector Comment					
DS_ID:20771 FS_ID:53997 EP_NO: N/A Repair Type: Non-Urgent Crossing Status: Found UCIP Comments: 5/14/2019 Record remains Non-Urgent. No permit has been identified authorizing pipe. Pipe is 50% silted throughout its entire lenght. Flap gate on WS is partially buried in mud that affects proper operation, visible gap between flap gate and pipe. Pipe crosses levee at an angle. (O.Yakimov - DWR UCIP)12/05/2016 Crossing has been downgraded from Urgent to Non-Urgent some debris blocking proper function of flapgate on WS. Recommend clearing debris from WS for flapgate to function properly. (O. Magana - DWR UCIP)10/01/2013 Debris blocking proper function of flapgate on WS toe. (W. Wylie - DWR UCIP) FIELD_STRUCT_DESC: 24-inch steel drainage pipe through the levee, 8.3 feet below the crown. Flap gate located on the waterside (WS) end. Concrete headwall located on the landside (LS). [Additional Reference(s): DWR Levee Log, 1992, (HLM 0.70). USACE Sacramento O&M Manual Unit 509, March 1957 revised October 1964, As-builts drawing 50-04-2394 (Station 155+40)]. FS Date: 5/14/2019 1:15:18 PM

View of pipe from LS

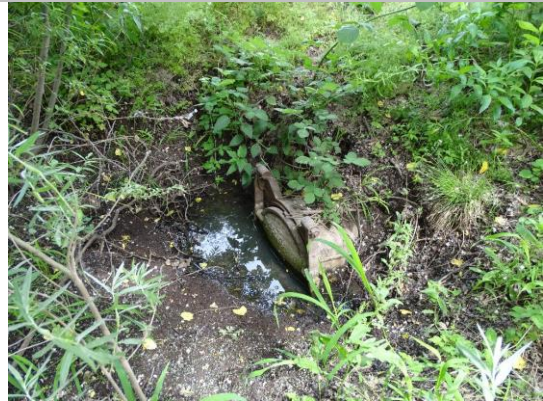
Photo 2 of 3 : UCIP_SP_2020_53997_79241.jpg

Flapgate on WS outlet

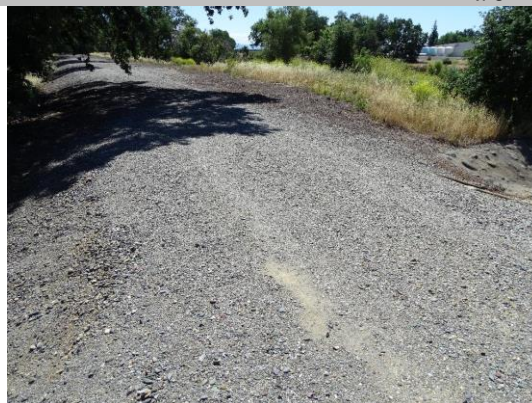
Photo 1 of 3 : UCIP_SP_2020_54114_79538.jpg

Comment Code						
Inspector Comment						
DS_ID:20775 FS_ID:54114 EP_NO: N/A Repair Type: Non-Urgent Crossing Status: Found UCIP Comments: 5/28/2019 Record updated from No Action Needed to Non-Urgent. No permit has been identified authorizing pipe. Debris at the outlet needs to be cleared for proper flap gate operation. (O.Yakimov - DWR UCIP) FIELD_STRUCT_DESC: 24-inch corrugated metal drainage pipe through the levee, 4.8 feet below the crown. Flap gate and concrete U-shaped headwall on the waterside (WS) end. Concrete U-shaped headwall on the landside (LS) end. [Additional Reference(s): DWR Levee Log, 1992, (HLM 0.26). USACE Sacramento O&M Manual 510, March 1957 revised October 1964, referenced as Unit No.1 left bank of Elder Creek, (HLM 0.26) Drawing No. 50-4-3622]. FS Date: 5/28/2019 7:19:25 AM

Top of Levee

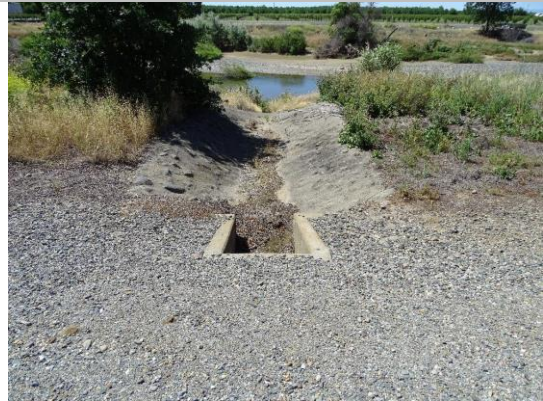
Photo 2 of 3 : UCIP_SP_2020_54114_79539.jpg

Water-Side

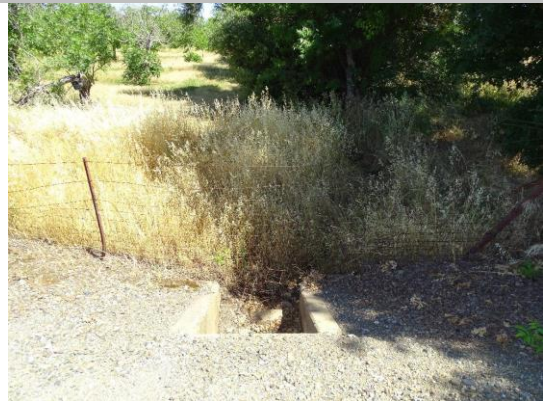
Photo 3 of 3 : UCIP_SP_2020_54114_79540.jpg

Land-Side

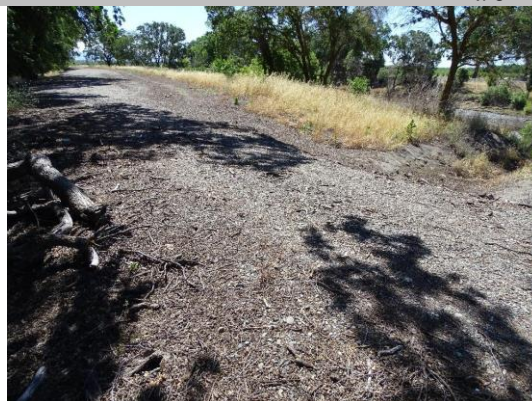
Photo 1 of 3 : UCIP_SP_2020_54115_79545.jpg

Comment Code					
Inspector Comment					
DS_ID:20776 FS_ID:54115 EP_NO: N/A Repair Type: Non-Urgent Crossing Status: Found UCIP Comments: 5/28/2019 Record updated from No Action Needed to Non-Urgent. No permit has been identified authorizing pipe. Debris at the outlet needs to be cleared for proper flap gate operation. (O.Yakimov - DWR UCIP) FIELD_STRUCT_DESC: 24-inch corrugated metal drainage pipe through the levee, 4.6 feet below the crown. Flap gate and concrete U-shaped headwall on the waterside (WS) end. Concrete U-shaped headwall on the landside (LS) end. [Additional Reference(s): DWR Levee Log, 1992, (HLM 0.33). USACE Sacramento O&M Manual 510, March 1957 revised October 1964, (HLM 0.39) Drawing No. 50-4-3622]. FS Date: 5/28/2019 9:41:55 AM

Top of Levee

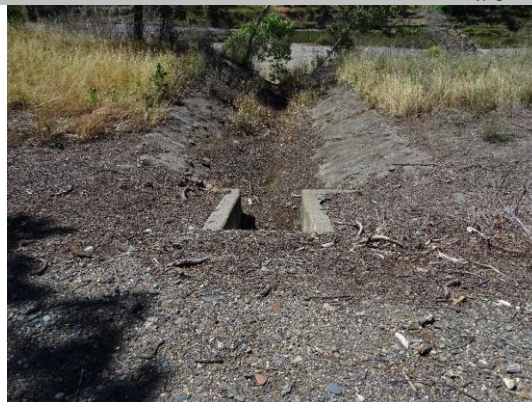
Photo 2 of 3 : UCIP_SP_2020_54115_79546.jpg

Water-Side

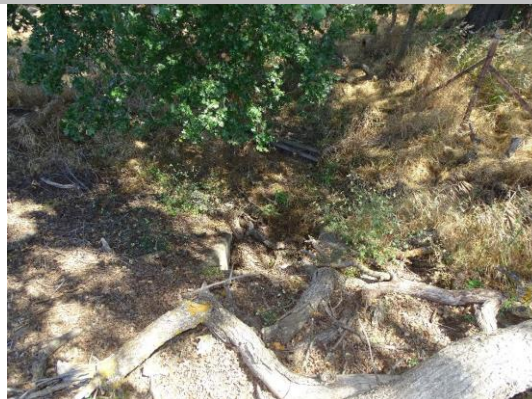
Photo 3 of 3 : UCIP_SP_2020_54115_79547.jpg

Land-Side

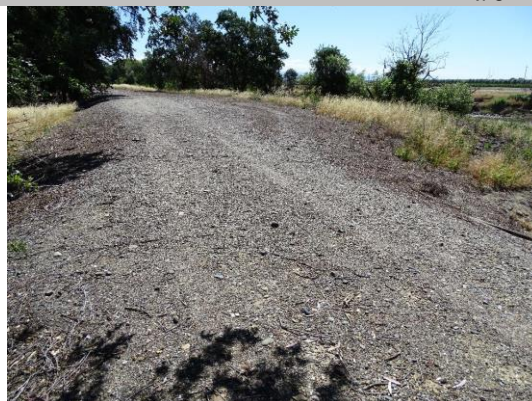
Photo 1 of 3 : UCIP_SP_2020_54116_79551.jpg

Top of Levee

Comment Code					
Inspector Comment					
DS_ID:20777 FS_ID:54116 EP_NO: N/A Repair Type: Non-Urgent Crossing Status: Found UCIP Comments: 5/28/2019 Record updated from No Action Needed to Non-Urgent. No permit has been identified authorizing pipe. Debris at the outlet needs to be cleared for proper flap gate operation. (O.Yakimov - DWR UCIP) FIELD_STRUCT_DESC: 24-inch corrugated metal drainage pipe through the levee, 5.6 feet below the crown. Flap gate and concrete U-shaped headwall on the waterside (WS) end. Concrete U-shaped headwall on the landside (LS) end. [Additional Reference(s): DWR Levee Log, 1992, (HLM 0.64), (HLM 0.51). USACE Sacramento O&M Manual 510, March 1957 revised October 1964, (HLM 0.52) Drawing No. 50-4-3622]. FS Date: 5/28/2019 9:54:39 AM

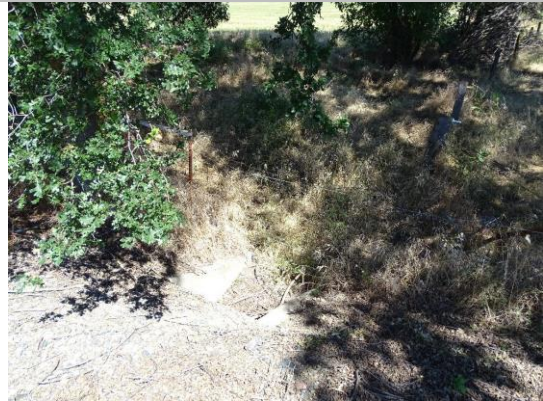
Photo 2 of 3 : UCIP_SP_2020_54116_79552.jpg

Land-Side

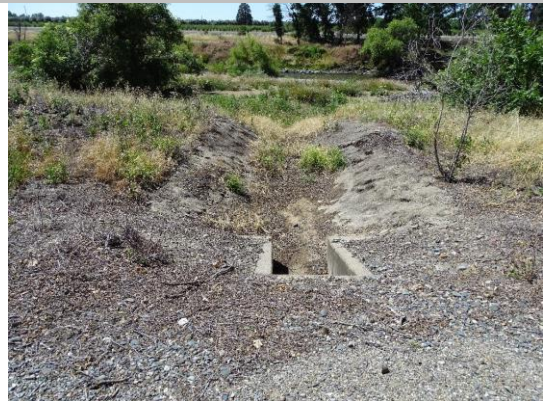
Photo 3 of 3 : UCIP_SP_2020_54116_79554.jpg

Water-Side

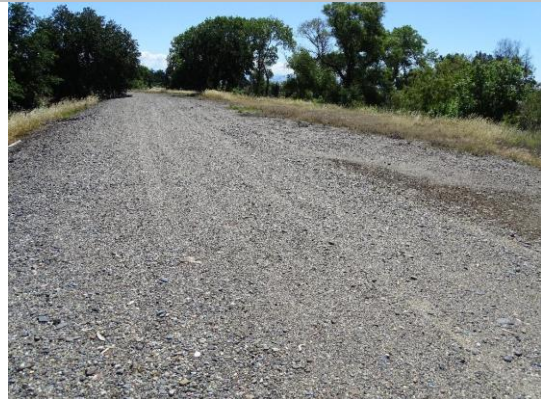
Photo 1 of 3 : UCIP_SP_2020_54117_79557.jpg

Comment Code					
Inspector Comment					
DS_ID:20778 FS_ID:54117 EP_NO: N/A Repair Type: Non-Urgent Crossing Status: Found UCIP Comments: 5/28/2019 Record updated from No Action Needed to Non-Urgent. No permit has been identified authorizing pipe. (O.Yakimov - DWR UCIP) FIELD_STRUCT_DESC: 1 of 2: 36-inch corrugated metal drainage pipe through the levee, 8.6 feet below the crown. Flap gate and concrete U-shaped headwall on the waterside (WS) end. Concrete U-shaped headwall on the landside (LS) end. [Additional Reference(s): DWR Levee Log, 1992, (HLM 0.64). USACE Sacramento O&M Manual 510, March 1957 revised October 1964, (HLM 0.65) Drawing No. 50-4-3622]. FS Date: 5/28/2019 10:22:34 AM

View of levee crown at crossing

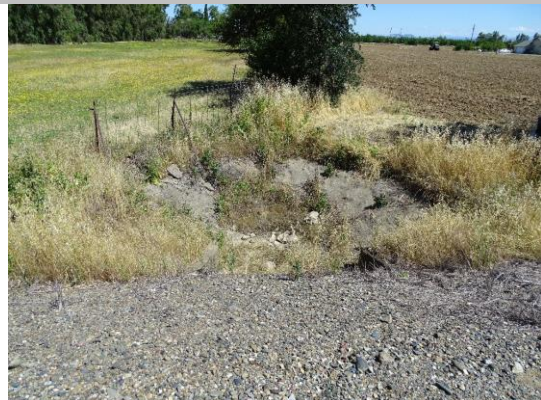
Photo 2 of 3 : UCIP_SP_2020_54117_79558.jpg

View of LS

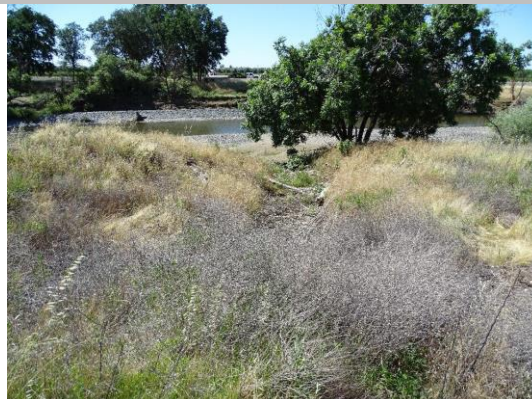
Photo 3 of 3 : UCIP_SP_2020_54117_79559.jpg

View of WS

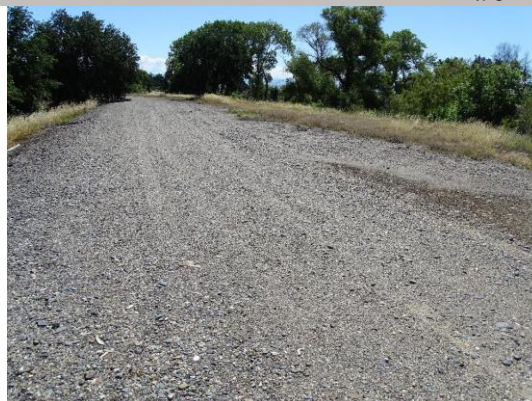
Photo 1 of 3 : UCIP_SP_2020_54118_79564.jpg

DS_ID:20880
 FS_ID:54118
 EP_NO: N/A
 Repair Type: Non-Urgent
 Crossing Status: Found
 UCIP Comments: 5/28/2019 Record updated from No Action Needed to Non-Urgent. No permit has been identified authorizing pipe.
 (O.Yakimov - DWR UCIP) 12/05/2016 Crossing has been downgraded from Urgent to Non-Urgent vegetation found on WS but does not appear to prevent proper function of flap gate. Recommend clearing dry vegetation on WS above concrete headwall.(O. Magana - DWR UCIP)10/03/2013 Flapgate operation hindered by soil and vegetation on WS toe. (W. Wylie - DWR UCIP)
 FIELD_STRUCT_DESC: 2 of 2: 36-inch corrugated metal drainage pipe through levee, 8.6 feet below crown. Flap gate and concrete "U" headwall located on the waterside (WS) end. Concrete "U" headwall located on the landside (LS) end. [Additional Reference(s): DWR Levee Log, 1992, (HLM 0.64). USACE Sacramento O&M Manual, Unit 510, March 1957 revised October 1964, As-built drawing No. 50-4-3622 (HLM 0.65)]

View of levee crown at crossing

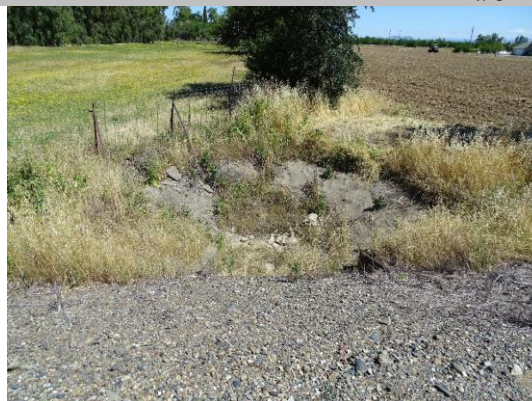
Photo 2 of 3 : UCIP_SP_2020_54118_79565.jpg

View of LS

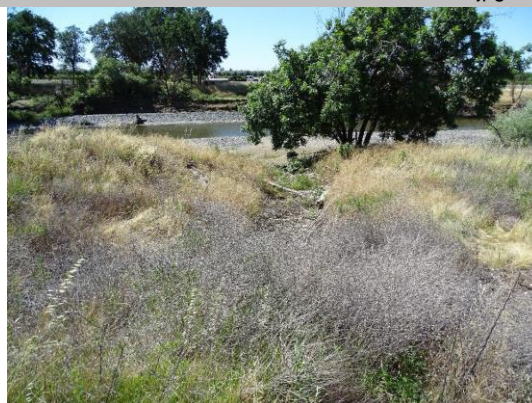
Photo 3 of 3 : UCIP_SP_2020_54118_79566.jpg

View of WS

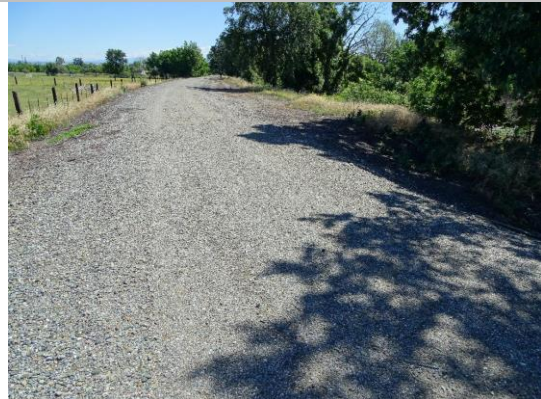
Photo 1 of 3 : UCIP_SP_2020_54119_79571.jpg

Comment Code						
Inspector Comment						
DS_ID:20779 FS_ID:54119 EP_NO: N/A Repair Type: Non-Urgent Crossing Status: Found UCIP Comments: 5/28/2019 Record updated from No Action Needed to Non-Urgent. No permit has been identified authorizing pipe. Pipe is partially filled with silt and debris. (O.Yakimov - DWR UCIP) FIELD_STRUCT_DESC: 24-inch corrugated metal drainage pipe through the levee, 5.8 feet below the crown. Flap gate and concrete U-shaped headwall on the waterside (WS) end. Concrete U-shaped headwall on the landside (LS) end. [Additional Reference(s): DWR Levee Log, 1992, (HLM 0.75). USACE Sacramento O&M Manual 510, March 1957 revised October 1964, (HLM 0.76) Drawing No. 50-4-3622]. FS Date: 5/28/2019 10:30:54 AM

Top of Levee

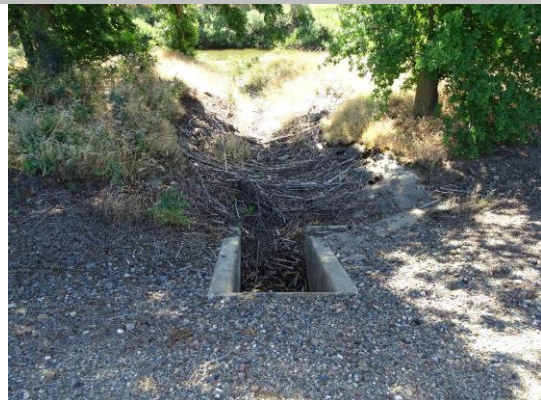
Photo 2 of 3 : UCIP_SP_2020_54119_79572.jpg

View of WS

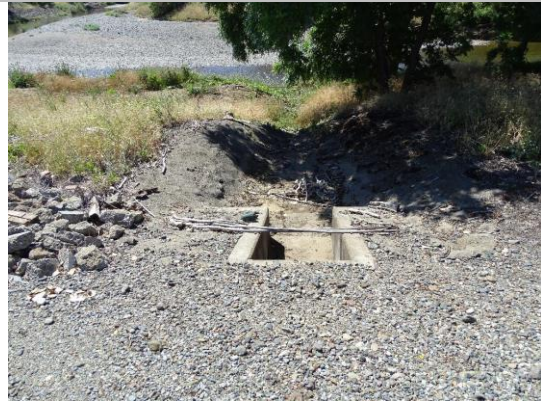
Photo 2 of 3 : UCIP_SP_2020_54120_79578.jpg

Concrete U-shaped headwall on WS toe

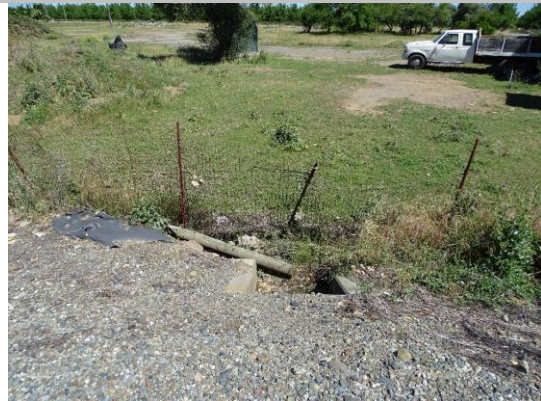
Photo 3 of 3 : UCIP_SP_2020_54120_79579.jpg

Concrete U-shaped headwall at LS toe

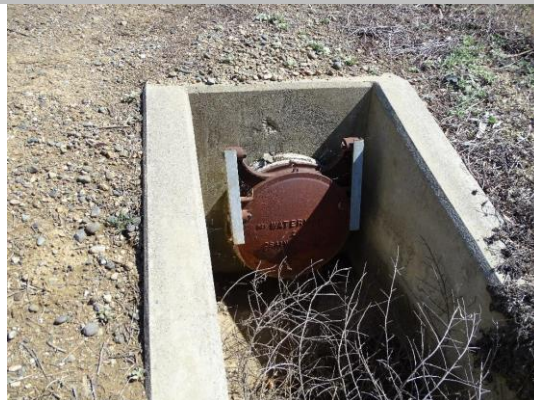
Photo 2 of 3 : UCIP_SP_2020_54121_79583.jpg

Comment Code						
Inspector Comment						
DS_ID:20790 FS_ID:54121 EP_NO: N/A Repair Type: Non-Urgent Crossing Status: Found UCIP Comments: 5/28/2019 Record updated from No Action Needed to Non-Urgent. No permit has been identified authorizing pipe. (O.Yakimov - DWR UCIP) FIELD_STRUCT_DESC: 24-inch corrugated metal drainage pipe through the levee, 5 feet below the crown. Flap gate and concrete U-shaped headwall on the waterside (WS) end. Concrete U-shaped headwall on the landside (LS) end. [Additional Reference(s): DWR Levee Log, 1992, (HLM 1.07). USACE Sacramento O&M Manual 510, March 1957 revised October 1964, (HLM 1.10) Drawing No. 50-4-3622]. FS Date: 5/28/2019 11:19:17 AM

Concrete U-shaped headwall and flapgate on WS toe

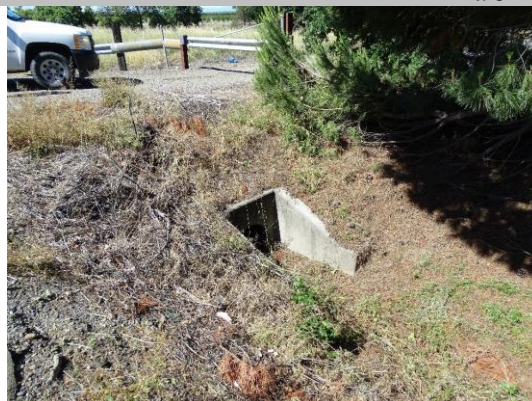
Photo 3 of 3 : UCIP_SP_2020_54121_79584.jpg

LS levee slope

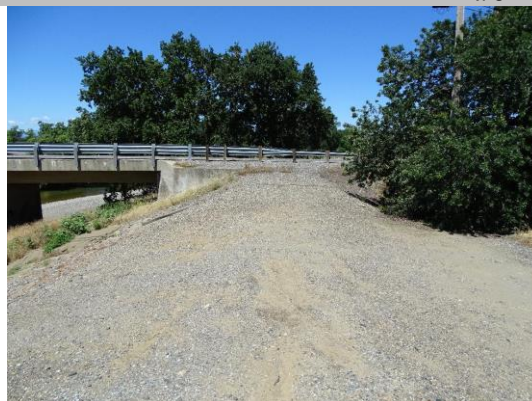
Photo 1 of 3 : UCIP_SP_2020_54123_79589.jpg

DS_ID:20773
 FS_ID:54123
 EP_NO: N/A
 Repair Type: Non-Urgent
 Crossing Status: Found
 UCIP Comments: 5/28/2019 Record updated from No Action Needed to Non-Urgent. No permit has been identified authorizing pipe.
 (O.Yakimov - DWR UCIP)
 FIELD_STRUCT_DESC: 24-inch corrugated metal drainage pipe through the levee, 5.1 feet below the crown. Flap gate and concrete U-shaped headwall on the waterside (WS) end. Concrete U-shaped headwall on the landside (LS) end. [Additional Reference(s): DWR Levee Log, 1992, (HLM 1.09). USACE Sacramento O&M Manual 510, March 1957 revised October 1964, (HLM 1.12) Drawing No. 50-4-3622].
 FS Date: 5/28/2019 11:34:16 AM

View of levee crown at the crossing
